2014 EXECUTIVE REPORT-
EXTERIOR RENOVATION INVESTIGATIVE STUDY

EXTERIOR RENOVATION INVESTIGATIVE STUDY

MILWAUKEE COUNTY HISTORICAL SOCIETY

910 North Old World Third Street
Milwaukee, Wisconsin 53203

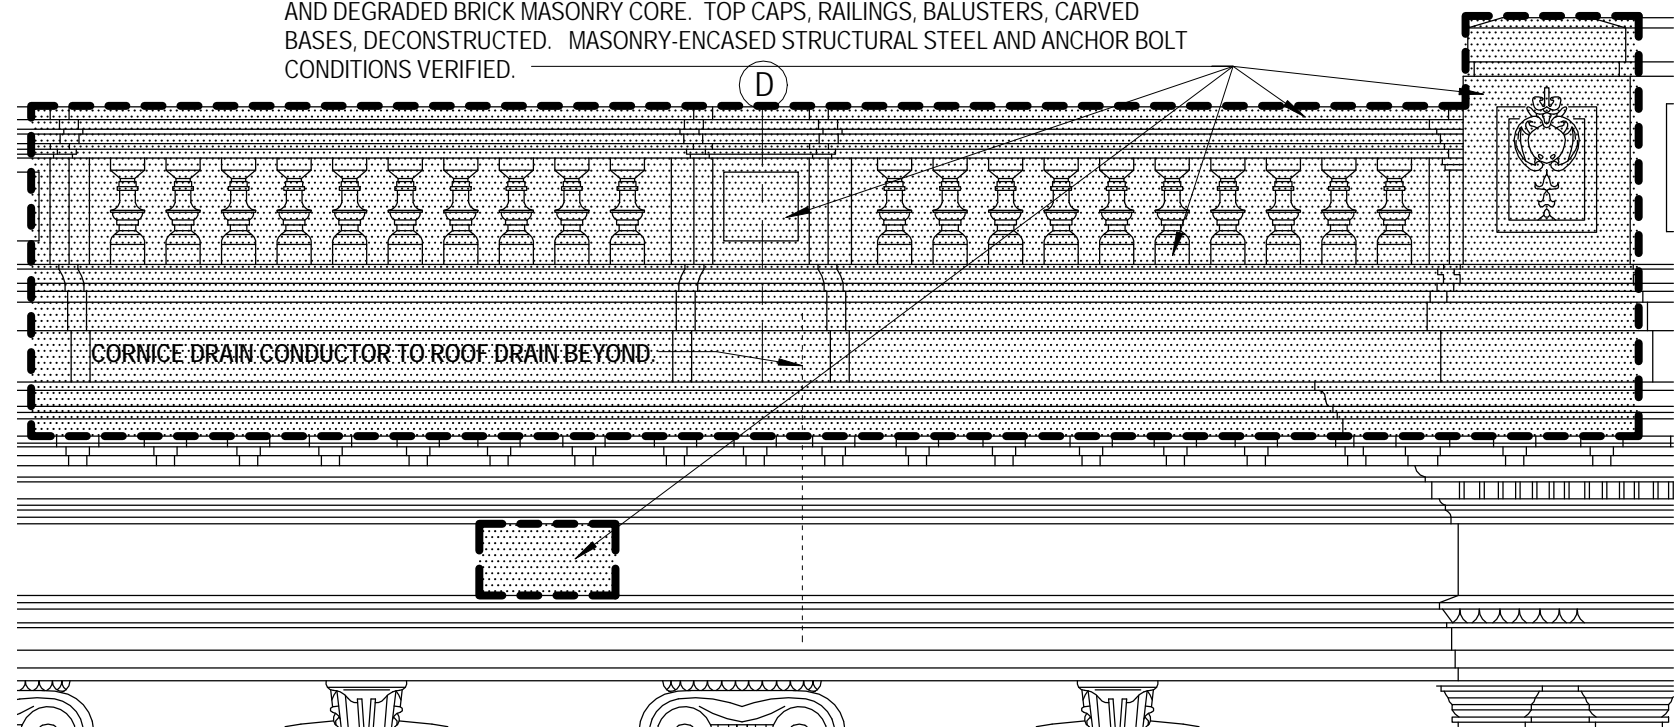
2 WEST ELEVATION - INVESTIGATION AREA
1/4" = 1'-0"

During deconstruction of the southern-end balustrade, deeper investigation into a structural steel anchor rod revealed minimal corrosion with no diminished structural integrity. The “C” channel embedded in the entablature similarly was examined and found to have slight corrosion and no degradation. The masonry surround was dry.

INDIANA LIMESTONE CLADDING PARTIALLY DECONSTRUCTED AT SOLID BALUSTRADE. BALUSTRADE PIER ASSEMBLY DECONSTRUCTED. FOUND CORRODED STRAP ANCHORS AND DEGRADED BRICK MASONRY CORE. TOP CAPS, RAILINGS, BALUSTERS, CARVED BASES, DECONSTRUCTED. MASONRY-ENCASED STRUCTURAL STEEL AND ANCHOR BOLT CONDITIONS VERIFIED.

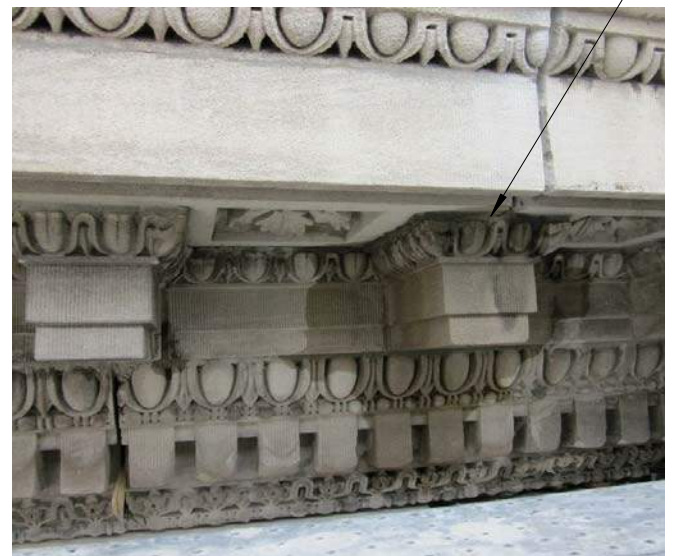
The on-going deterioration of the projecting limestone cornice is primarily due to failed flat-seams and inadequate drainage of the copper gutter. A section of the gutter was cut away to assess the condition of the limestone unit. Previous power nailing to anchor the copper gutter had split the limestone cornice edge. A cementitious epoxy material, painted to match the adjacent stone, was employed to patch the fractured edge. In addition to these conditions of dangerous spalling, water was observed infiltrating the limestone entablature. This seepage behind the carved limestone units underneath the projecting cornice, weakens the brick back-up wall assembly and the embedded mild steel strap anchors.

COPPER GUTTER REMOVED. REVEALED WET LIMESTONE CORNICE AND THE SEVERELY-SPALLED EDGE. PAST MAINTENANCE HAD PATCHED AND PAINTED THE CORNICE EDGE.

CONSTANT DRIPPING OF LONG-STANDING WATER IN CORNICE GUTTER. EVIDENCE OF SEEPAGE INTO LIMESTONE MASONRY WALL ASSEMBLY.

The severely, spalled cornice edge can be repaired by removing the damaged edge. A new piece of stone will be keyed to the existing 7000 lb. limestone unit. This limestone Dutchman covers the entire cornice of the building perimeter. The new Indiana limestone will have a different patina. It will appear as an imperfect color match to its weathered receiver. *(A301, 3/A401)*

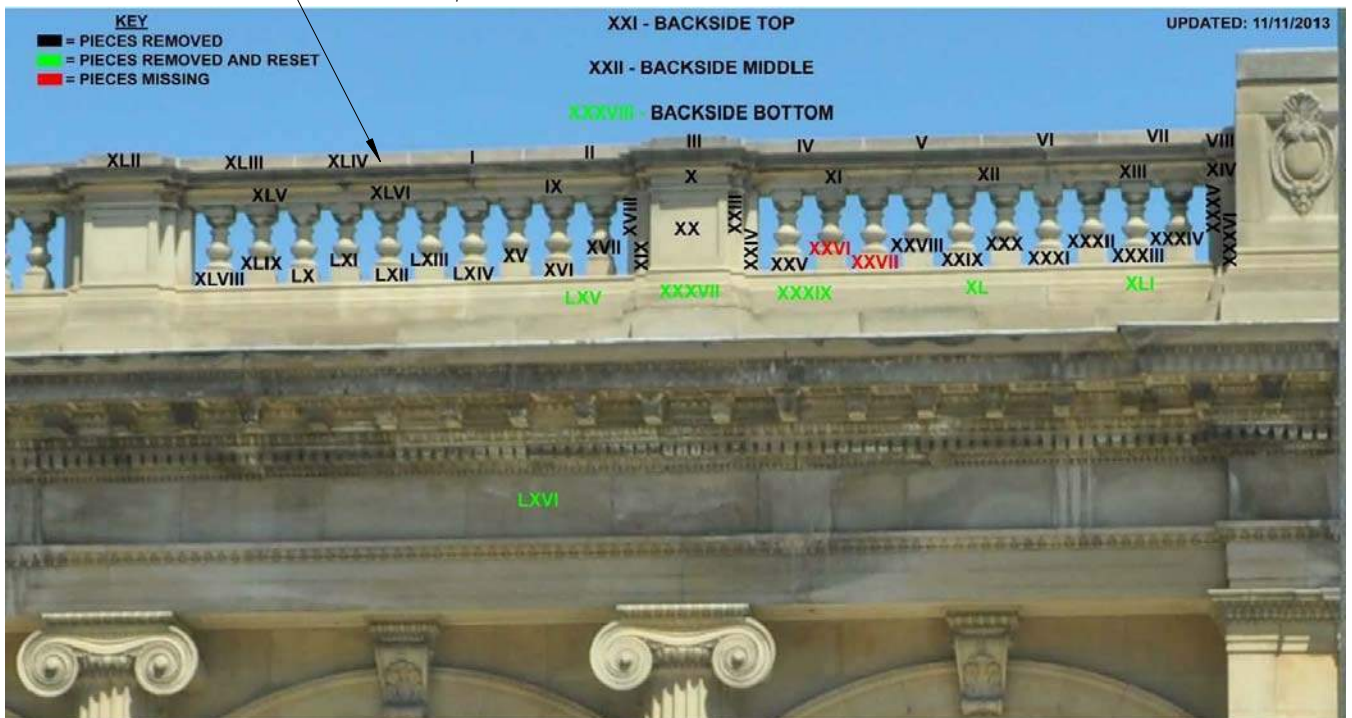
INDIANA LIMESTONE UNITS DECONSTRUCTED, SURVEYED, NUMBERED, PALLETIZED, STORED AT MILWAUKEE COUNTY'S JACKSON PARK YARD.

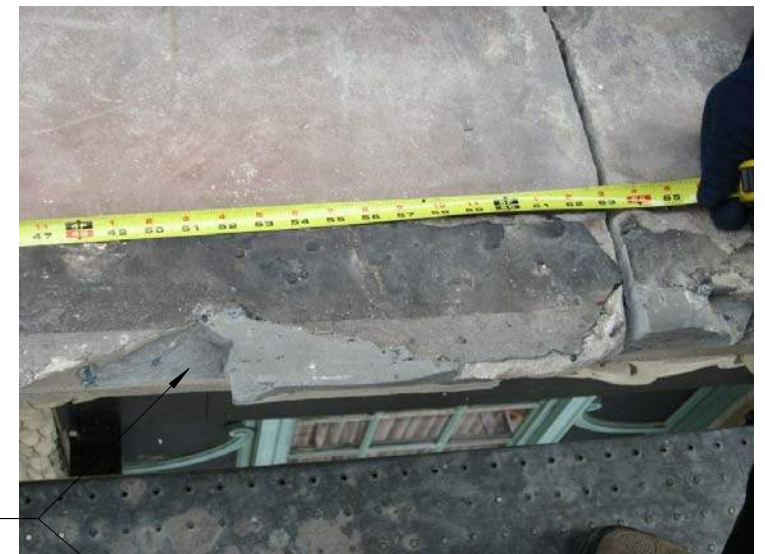
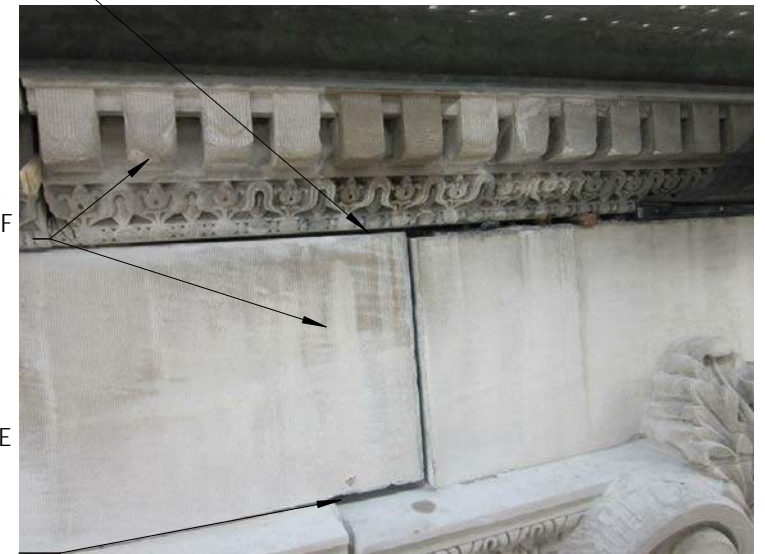
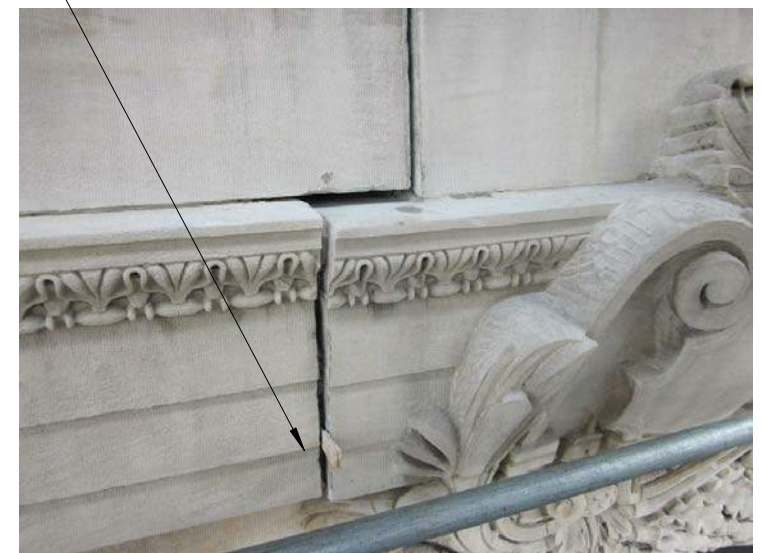
SECTION B - B

WORST-CASE CONDITION AT ONE OF SEVEN CARTOUCHE LOCATIONS. KEYSTONE UNITS SHIFTED DOWN AND OUT OF PLANAR ALIGNMENT.

The re-alignment of the most displaced limestone cartouche will necessitate the complete deconstruction and rebuild of the wall's full-depth including the solid balustrade above. An assessment of the conditions necessitating the displacement will inform the subsequent stabilization of at least four of the remaining six cartouche assemblies. (Total of seven cartouche.) Alternatively, given that the assembly works as a true arch, a repair-in-place is feasible. Approximated life-span is 25 years. The visual displacement would remain.
(1/A301)

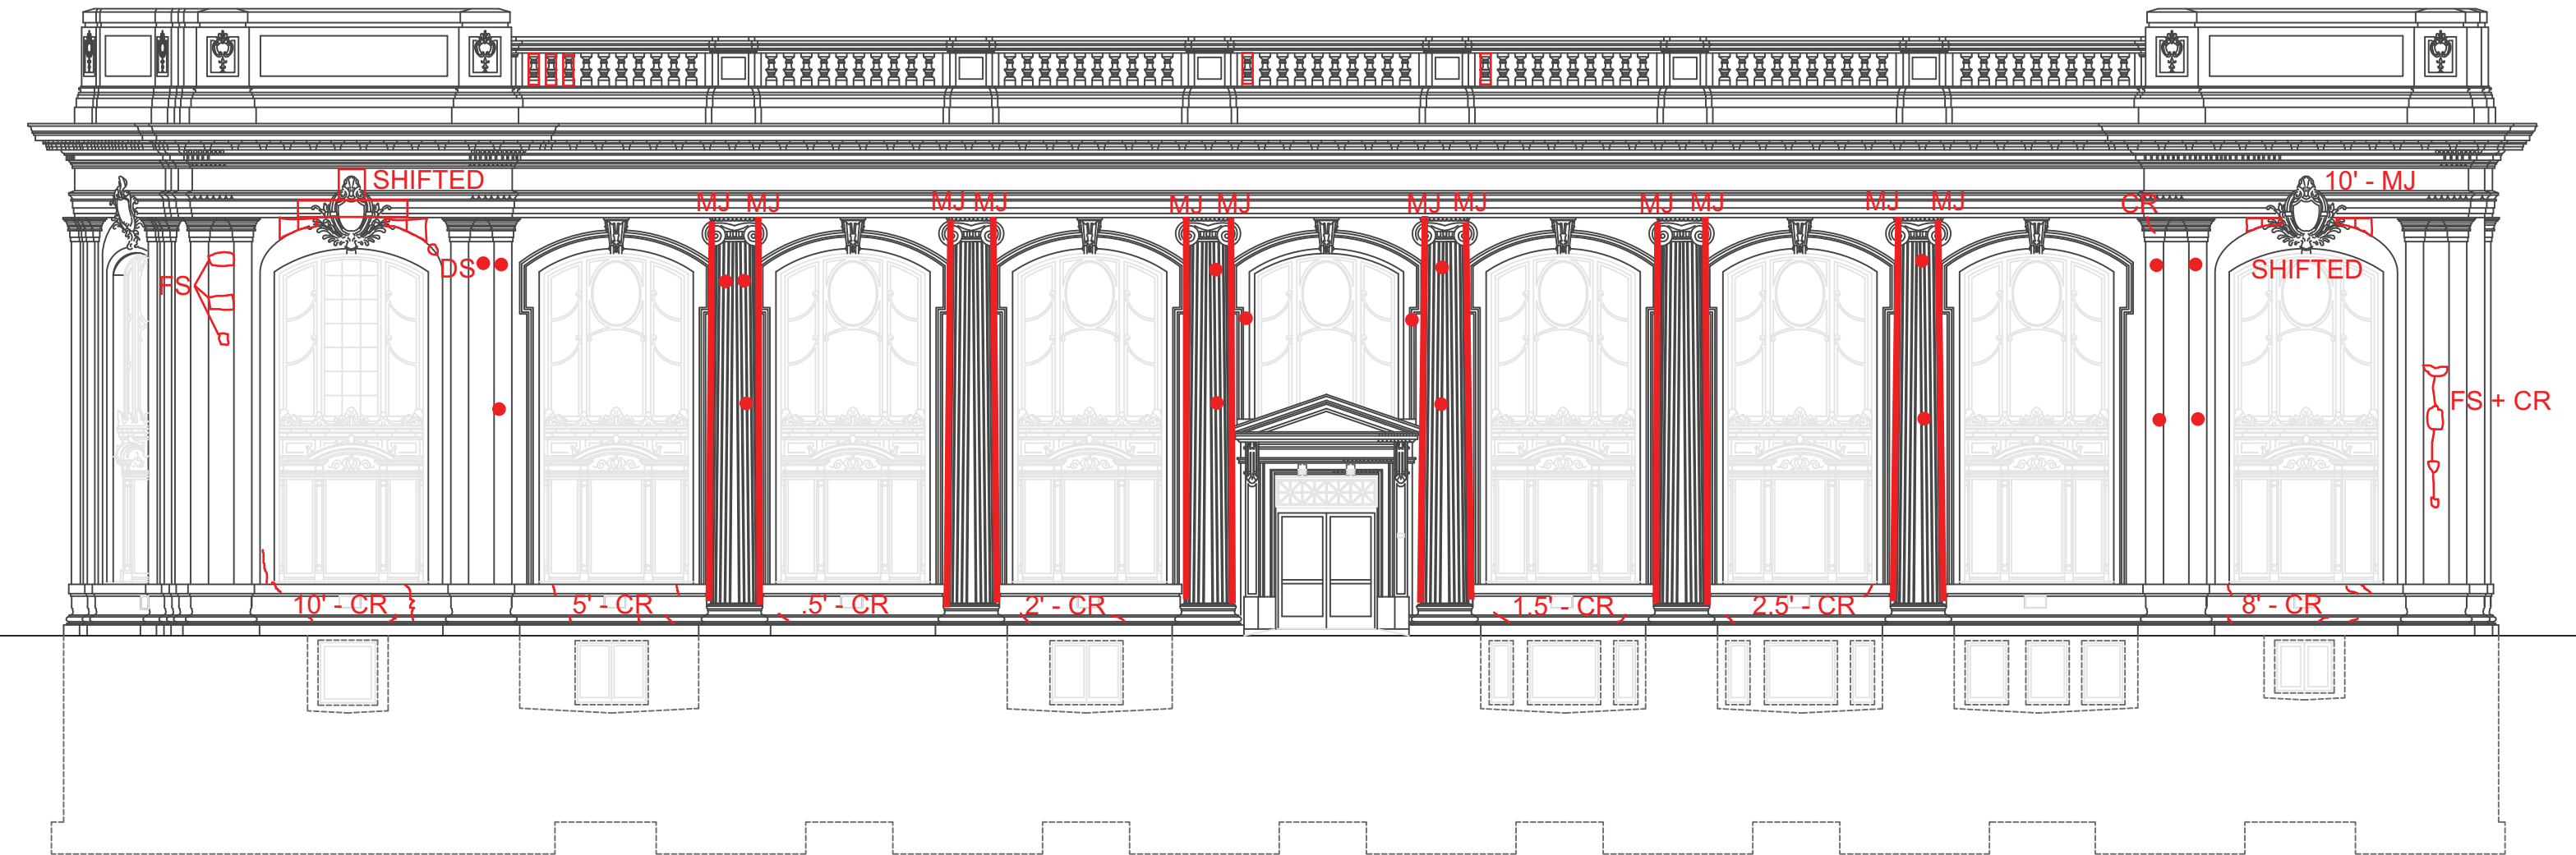
3rd Street Elevation (WEST)

2' - SKY 5' - MJ	6.5' - SKY 8.5' - MJ	6.5' - SKY 8.5' - MJ	6.5' - SKY 8.5' - MJ	6.5' - SKY 8.5' - MJ	4' - SKY AT DOOR 10' - MJ AT HEADER 5' - MJ AT DOOR	2' - MJ	6.5' - SKY 5' - MJ	6.5' - SKY 8.5' - MJ
1' - SKY 3' - MJ							1' - SKY 3' - MJ
